# WATERSHED IMPLEMENTATION PLAN

December 2009

## Middle Spring Creek Gum Run & Mains Run Cumberland and Franklin Counties, Pennsylvania

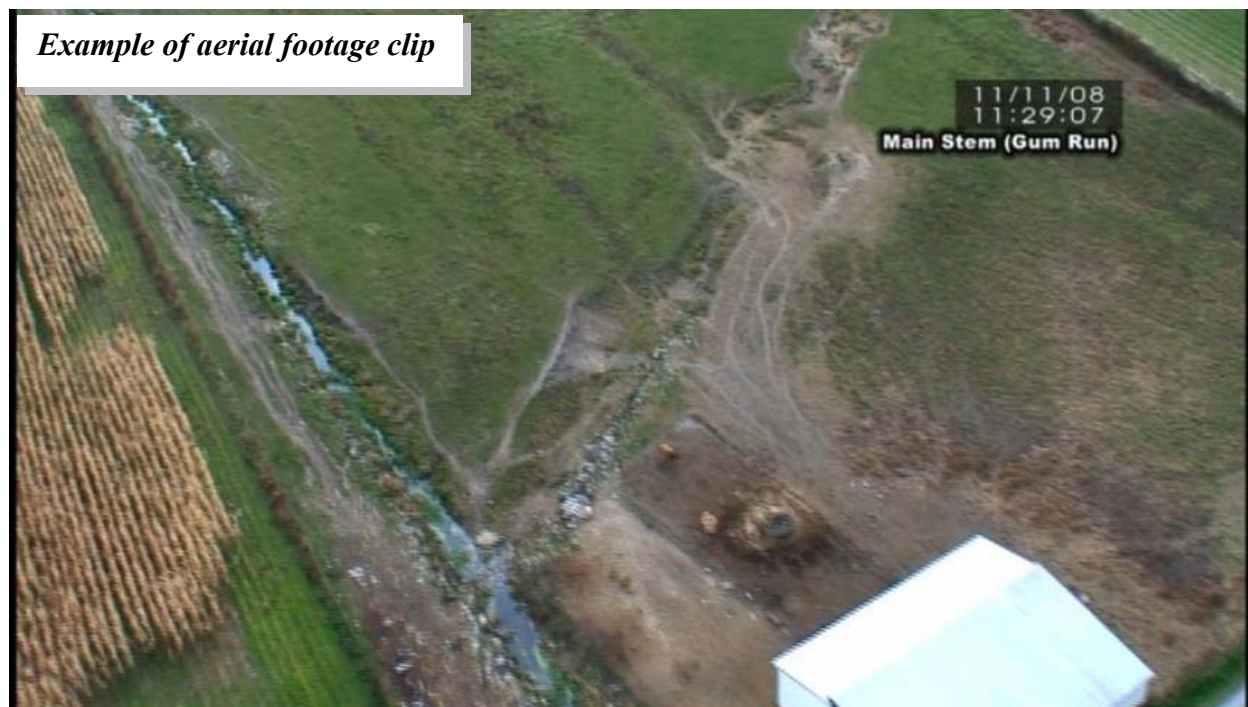
Most aerial videoing took place from an altitude between 400 – 600 feet above the ground. The video was time coded and linked to a GPS unit so that site locations could be known and in turn linked to GIS programming for further analysis and planning.

After the flights were completed, collected video footage was post-processed. This involved dividing out the various sub-watersheds using the associated time code and collected GPS coordinates. Once adequately post-processed, the video footage was placed on a DVD disk for viewing at any time. All 28-miles of collected stream corridor video are on the DVD.

At the same time, RETTEW staff combined the known flight paths with GIS technology; thus a flight path layer can be “turned on” while using ArcView. The flight paths simply depict and indicate where the helicopter flew. Using other ArcView available functions, a user can use the time code viewed on the video clips to find that exact point within the GIS program mapping by selecting the proper flight path. This then allows the user to earmark the potential problem site, typically indicated by drawing a line or polygon along or around the area of concern.

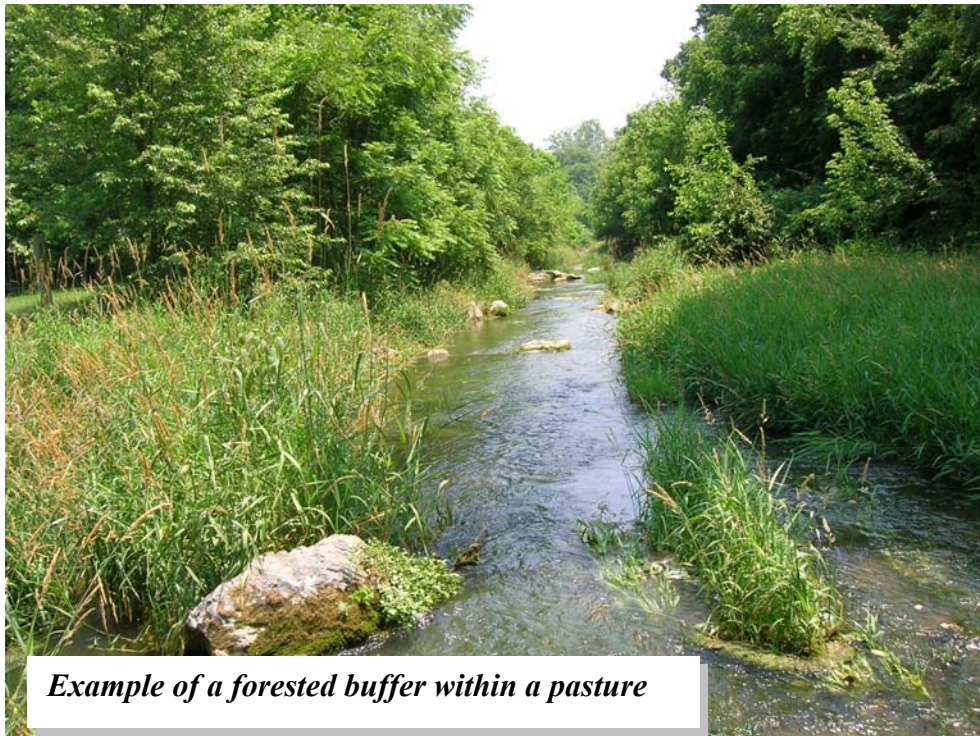
*Example of a forested buffer within a pasture*
